MACK PROPERTY INSPECTIONS, LLC
Exceeding Industry Standards

INSPECTION REPORT

1234 Main St.
ABCDE FG 56789

08/28/2018 9:00AM

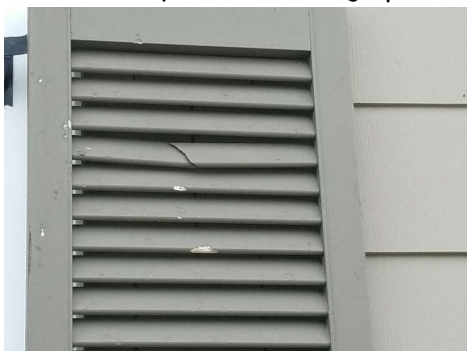
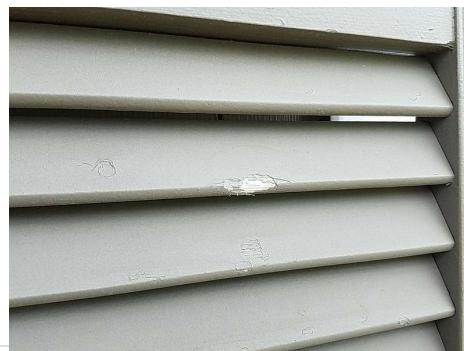
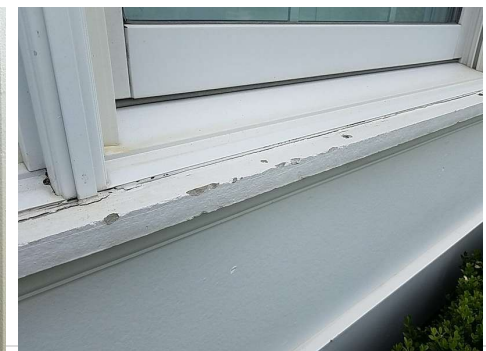
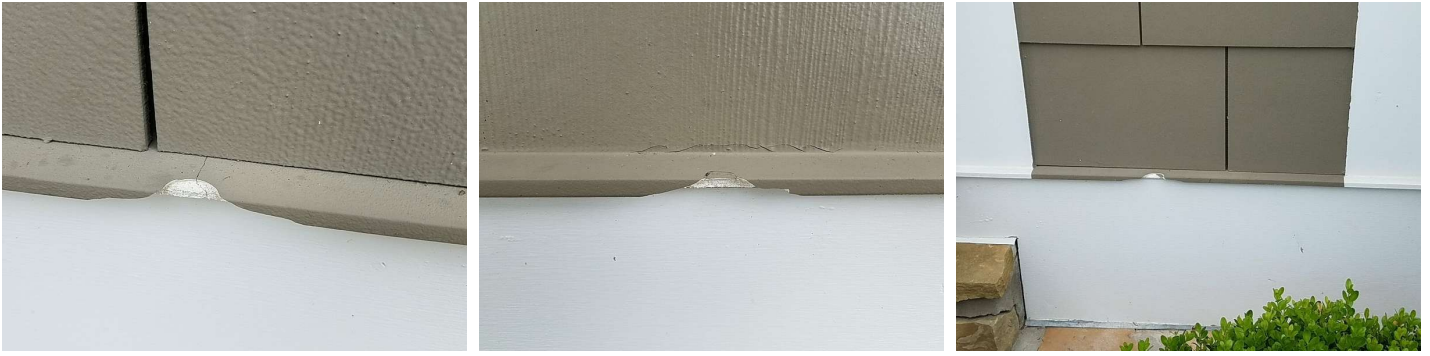
There are blemishes in the surface at several areas around the home (primarily on the front wall - west side facing directional weather). The blemishes are in the surface of the shutters and trim pieces. Wood surfaces should be repaired and painted to discourage deterioration. The blemishes on the trim pieces are mainly aesthetic and can be replaced as desired.

Contact a qualified siding specialist.

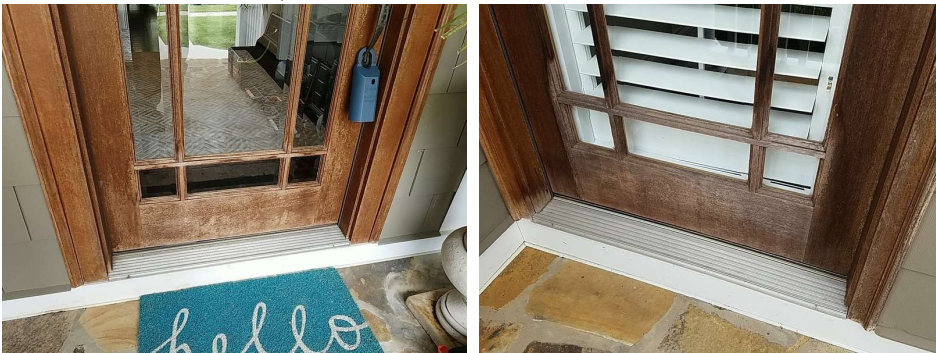
2.4.1 Exterior Doors

WEAK STAIN ON DOORS

The stain is weak on the front exterior doors. This is normal to occur, especially for doors facing west and exposed to sunlight. The doors can be re-stained as desired.

Contact a qualified painter.

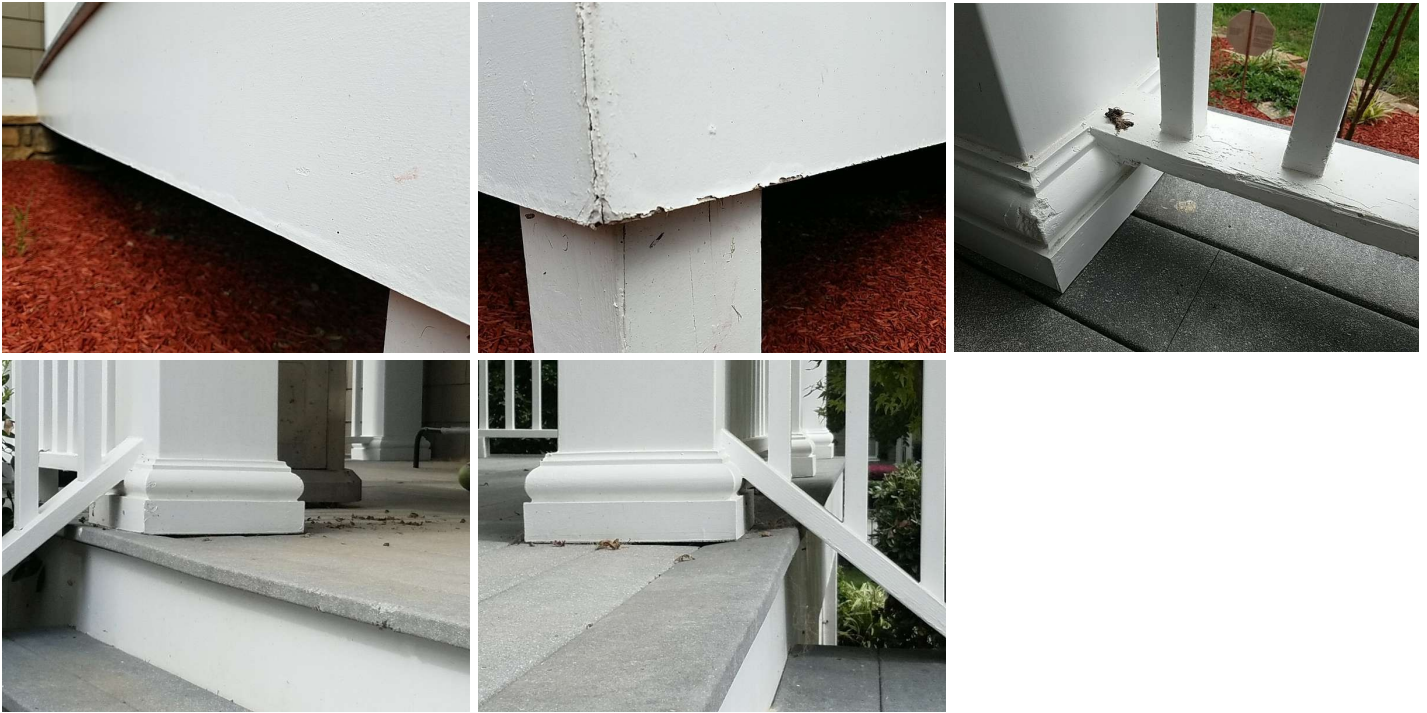
2.5.1 Deck

MISCELLANEOUS DECK CONCERNS

- The trim board along the outer perimeter of the deck is weathered. Re-painting the board can help to discourage deterioration.
- Some of the rails are scuffed (caused by pet/s).
- The surface is not level along the outer edge. There were visible issues with the framing below the outer end.

These items do not affect functionality or integrity and can be repaired or addressed as desired.

Contact a qualified deck contractor.

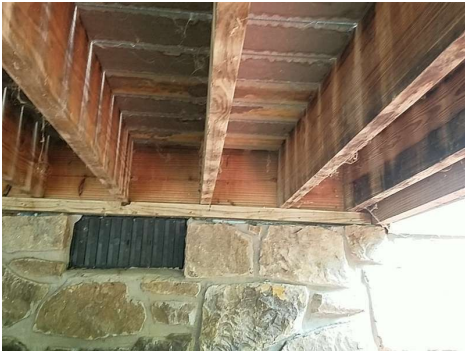
2.5.2 Deck

LEDGER NOT BOLTED

Contact a qualified deck contractor.

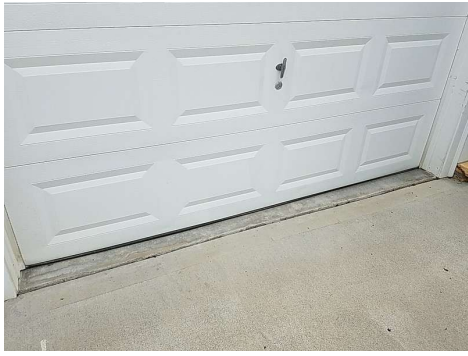
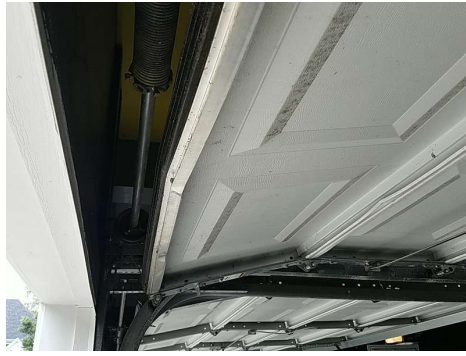
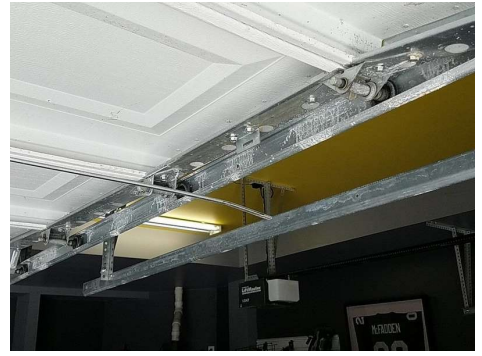
DOOR PANEL BENT AND LOCK ARM IS LOOSE

The right hand garage door is bent (bottom panel). This does not affect functionality of the door. The panel can be replaced as desired.

Contact a qualified garage door contractor.

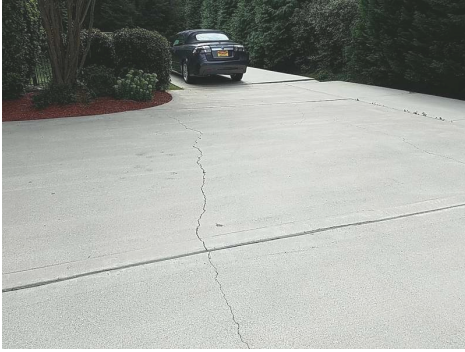
Walkways and Driveways: Common Settlement Cracks

Settlement cracks are common to occur and typically are not a reflection of a significant concern. I recommend keeping all cracks sealed to discourage water entry and further cracking and deterioration.

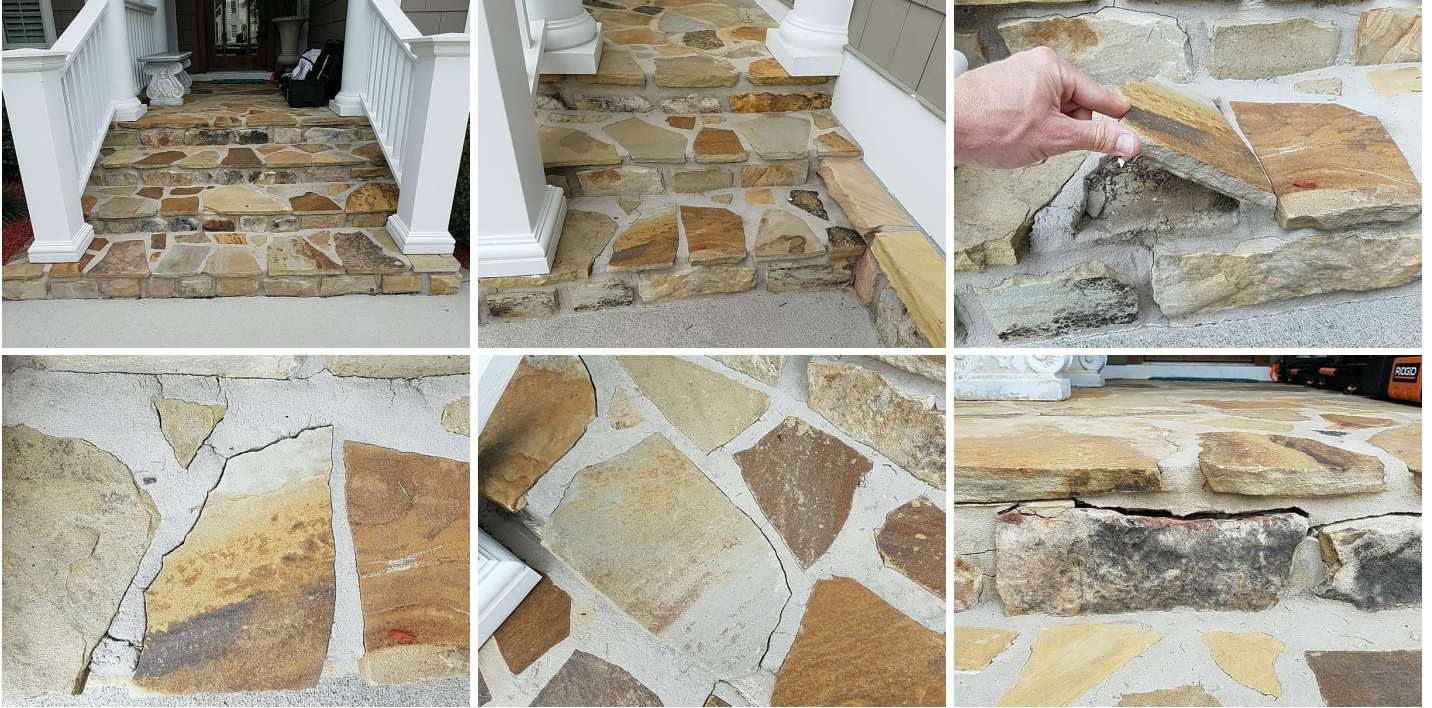
Some of the stones are loose at the porches on the front of the home. In addition, there are cracks in the mortar between the stones at various locations. All loose stones should be properly secured and any open joints in the mortar should be sealed to discourage further deterioration.

Contact a qualified masonry professional.

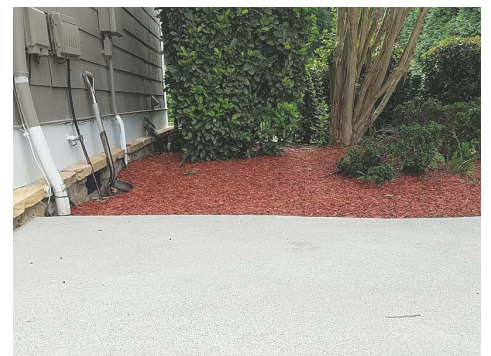
4.4.1 Grading and Drainage

NEGATIVE GRADING

Areas of the soil do not maintain proper slope away from the foundation. This could allow surface water to flow towards the foundation. All areas of the soil around the home should slope away from the foundation to encourage proper drainage away from the structure. If proper grading cannot be achieved, alternative means of drainage may be necessary (surface drain, french drain, etc.).

Contact a qualified grading contractor.

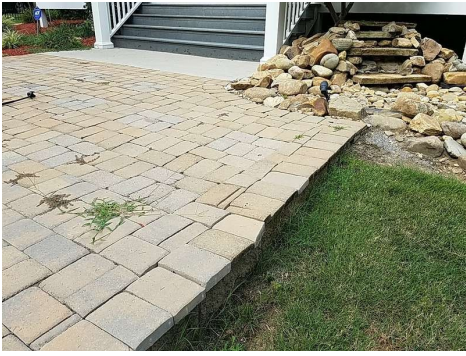
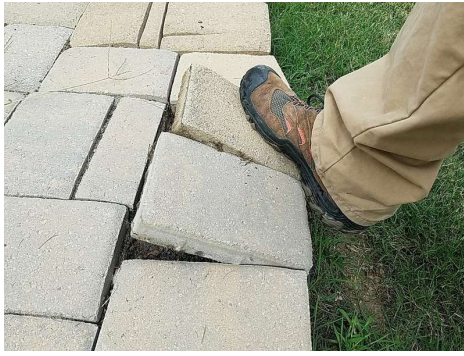
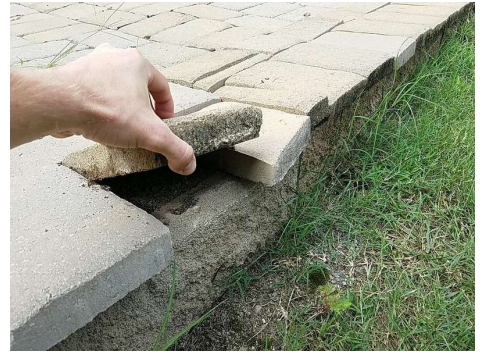
4.5.1 Patio

LOOSE PAVERS

Some of the pavers are loose along the edge of the patio. This is a potential trip hazard. I recommend all pavers be properly secured.

Contact a qualified general contractor.

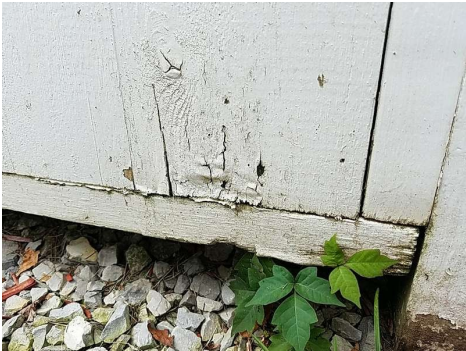
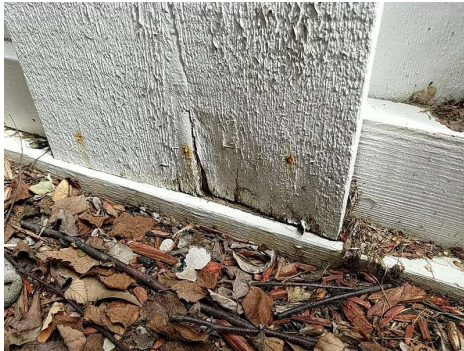
4.7.1 Fence

DAMAGE TO FENCE BOARDS

Some of the boards are beginning to rot on the privacy fence around the HVAC equipment. The boards can be repaired or replaced as necessary.

Contact a qualified handyman.

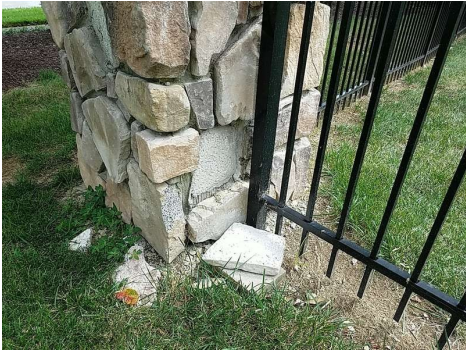
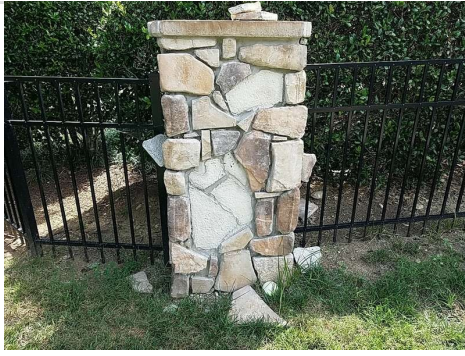
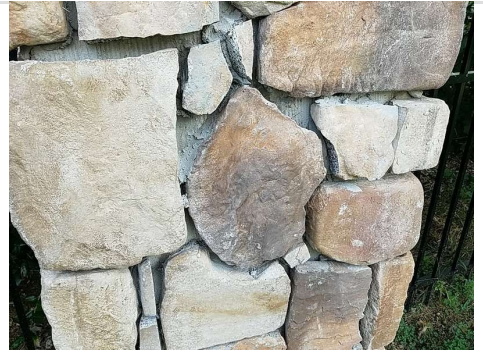
4.7.2 Fence

LOOSE STONES ON COLUMNS

The stonework is incomplete on the columns for the fence. Some of the stones have come loose and there is no mortar between the stones.

Contact a qualified masonry professional.

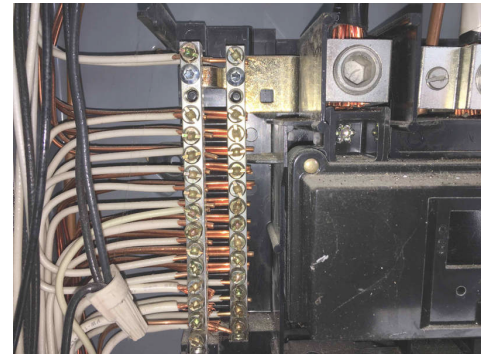
5.3.1 Distribution Panel

DOUBLE TAPPED NEUTRAL

This item does not affect functionality of the system and can be repaired as necessary (in context with other electrical repairs that may be performed).

Contact a qualified electrical contractor.

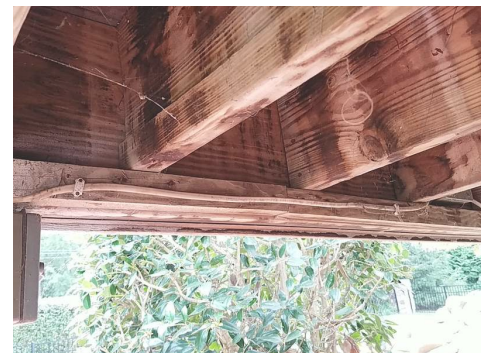
5.4.1 Branch Wiring

EXTERIOR WIRE NOT IN CONDUIT

The wire at the listed location is not contained in conduit. This may result in damage to the wire and is a potential shock hazard if the wire is damaged. I recommend all exterior wires be contained in protective conduit.

Contact a qualified electrical contractor.

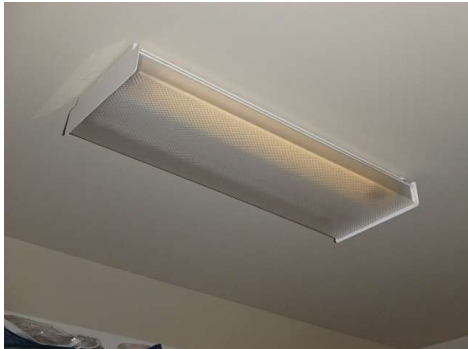
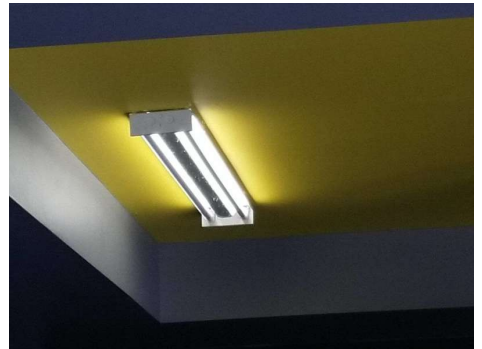
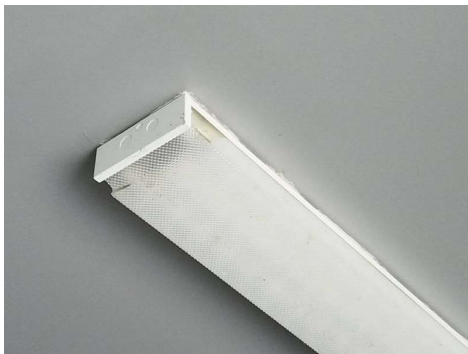
The fluorescent lights in the guest bedroom closet and garage are not working. I suspect the bulb or the ballast is bad and should be replaced.

In addition, the cover has been removed from one of the lights in the garage and the cover is broken on the other light in the garage. The covers can be replaced.

Contact a qualified handyman.

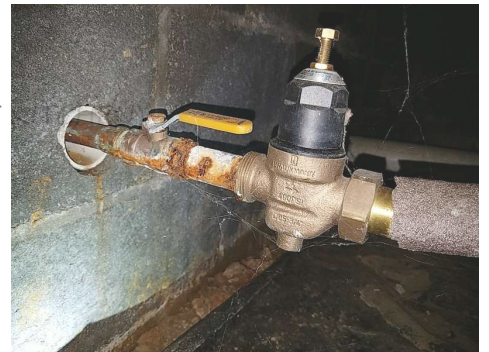
CORROSION ON PIPING

There is corrosion on the water piping at the listed location. The affected pipe should be replaced to ensure prevent undetected leaks.

Contact a qualified plumbing contractor.

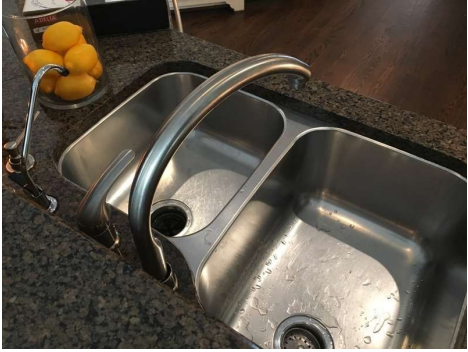
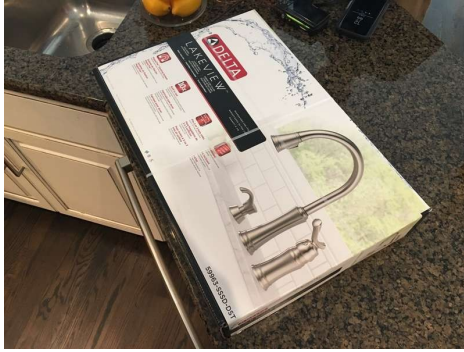
7.5.1 Kitchen Sink

FAUCET TO BE REPLACED

The kitchen sink faucet is broken. A new faucet is intended to be installed prior to closing.

Contact a qualified plumbing contractor.

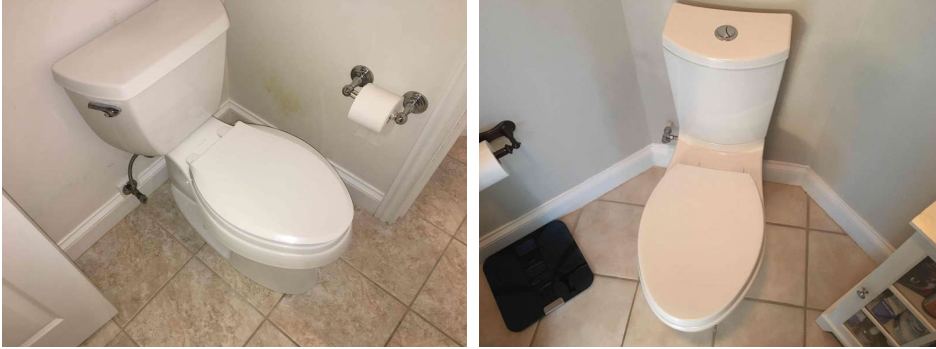
7.6.1 Bathrooms

TOILET LOOSE / NOT SECURED

The toilet is not secured tightly to the floor at the listed location. This raises potential for leaks at the seal. Necessary repairs should be made to secure the toilet and ensure there are no leaks or underlying concerns.

Contact a qualified plumbing contractor.

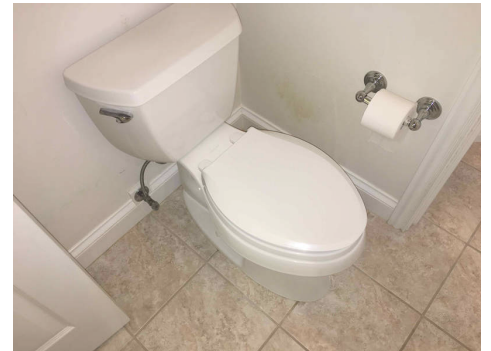
7.6.2 Bathrooms

TOILET - WATER RUNS

The water continuously runs at the toilet at the listed location. The internal components will need to be repaired / replaced.

Contact a qualified plumbing contractor.

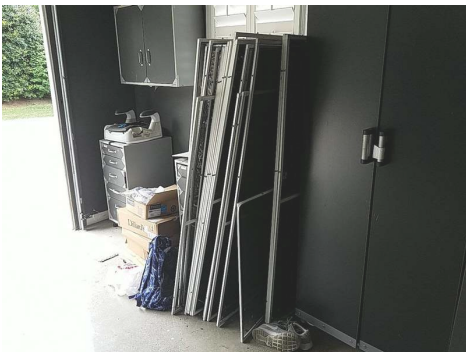
Windows: Screens Not Installed

There are no screens installed on various windows. NOTE: the screens are installed in the garage.

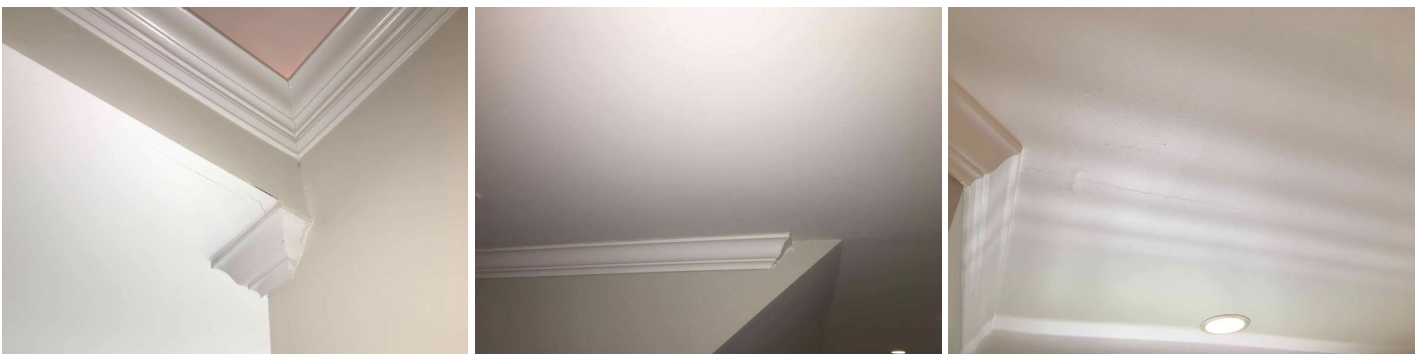
Walls and Ceilings: Settlement Cracks, Nail Pops, and/or Loose Tape Joints

There were settlement cracks, nail pops, and loose tape joints in the drywall at various walls and ceilings. The cracks, loose tape joints, and nail pops, are common to occur due to normal settling and/or to the

expansion and contraction that occurs when heating and cooling the home.

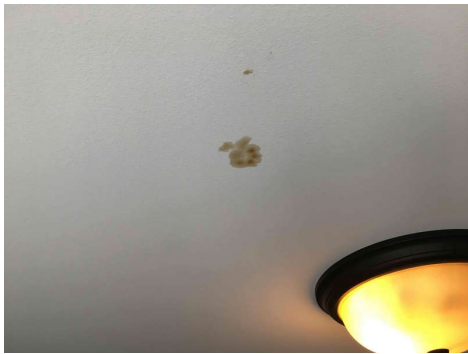
Upper Level Bedroom

There is a stain on the ceiling in the rear guest bedroom. This appears to be a surface stain and is not an indication of any previous leak or concern. The stain can be cleaned / removed and the ceiling re-

... painted as necessary.

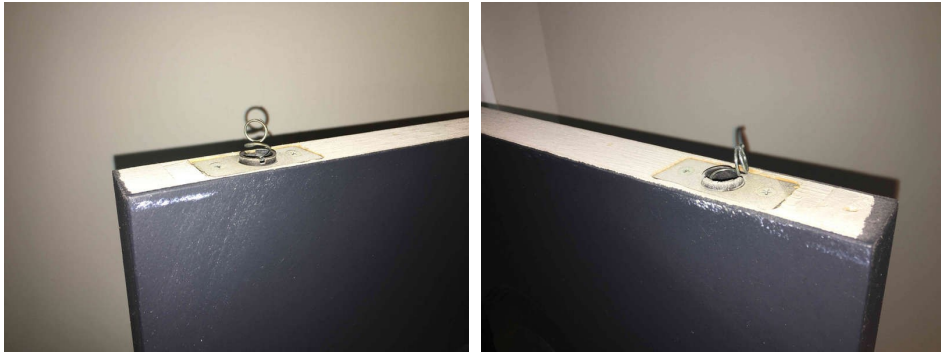
BALL CATCH BROKEN

The ball hinge is broken on the door in the master bathroom. The hinge will need to be repaired / replaced.

Contact a qualified door repair/installation contractor.

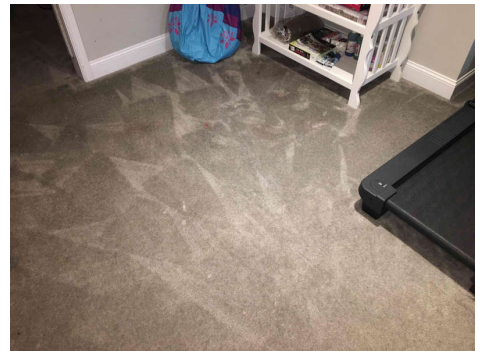
8.5.1 Floors

CARPET STAINS

The carpet is stained at various locations. The carpet can be cleaned or replaced as desired. NOTE: Some stains may not be able to be removed.

Contact a qualified flooring contractor

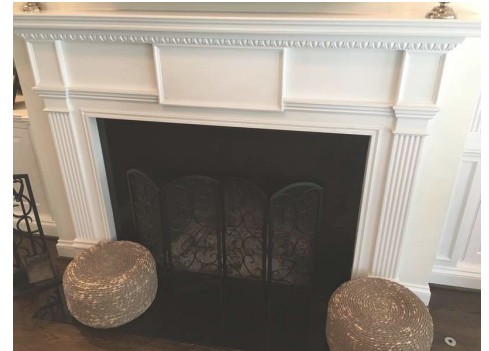
9.4.1 Fireplace

RECOMMEND CLEANING

I recommend having the fireplace flue professionally cleaned / swept.

Contact a qualified fireplace contractor.

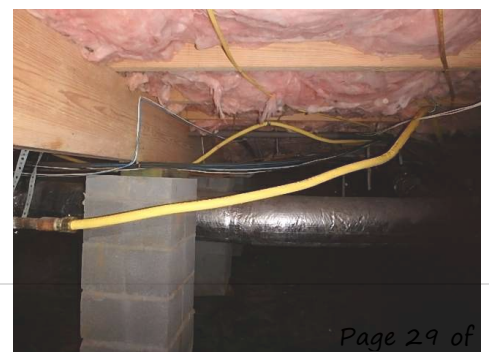
9.5.1 Gas Service and Piping

CSST PIPE BONDING

There is CSST gas piping routed in the home. This type of piping is required to be bonded to the main grounding system. You can read more about this type of piping at [this link](#). I

recommend contacting a licensed electrician to verify the piping is properly bonded to the main grounding system as suggested by the pipe manufacturer.

NOTE: All electrodes used must be bonded together into one common grounding electrode system. A separate grounding electrode and grounding system cannot be established just for the fuel gas piping system.

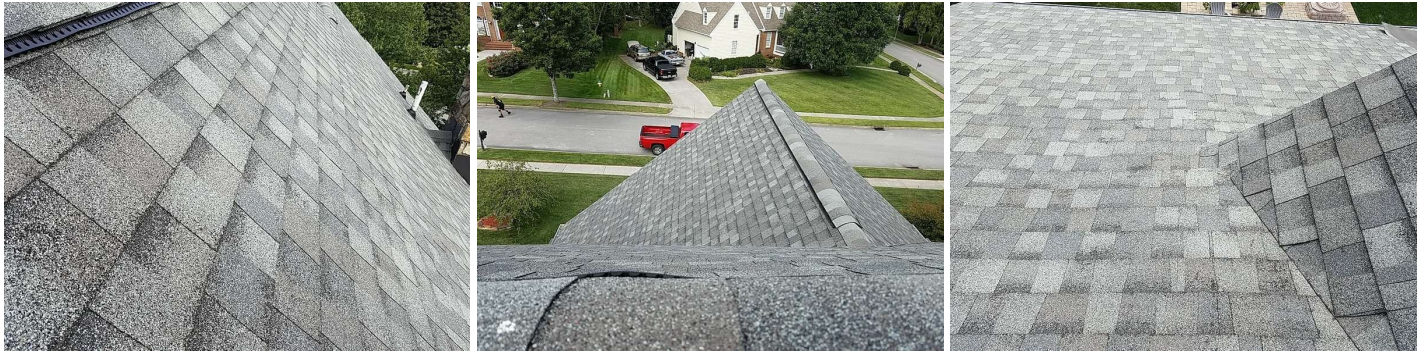
Shingles: New Dimensional

The shingles are new. This shingle will generally last around 20-25 years in our climate depending on weather conditions and general maintenance.
