MACK PROPERTY INSPECTIONS, LLC
Exceeding Industry Standards

INSPECTION REPORT

1234 Main St.
ABCDE FG 56789

08/28/2018 9:00AM

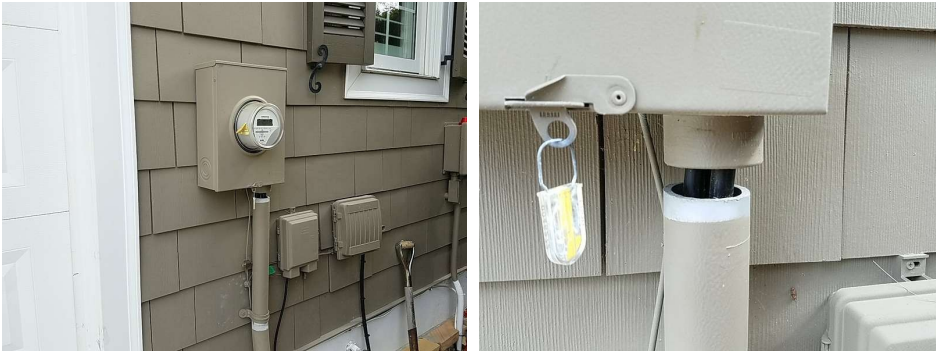
5.3.1 Distribution Panel

DOUBLE TAPPED NEUTRAL

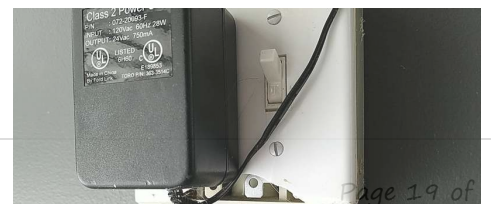
Cracked / broken cover plates were observed on the electrical fixtures. NOTE: I recommend replacing damaged covers.

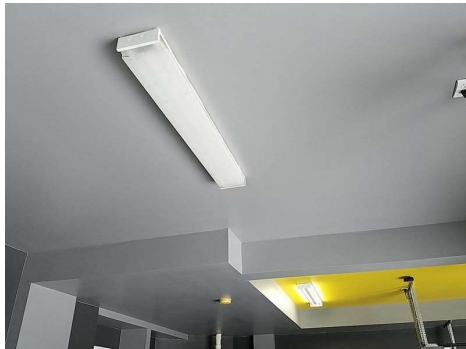
5.7.1 Smoke Detectors

NOT SECURED PROPERLY

Recommendation

Contact a qualified handyman.

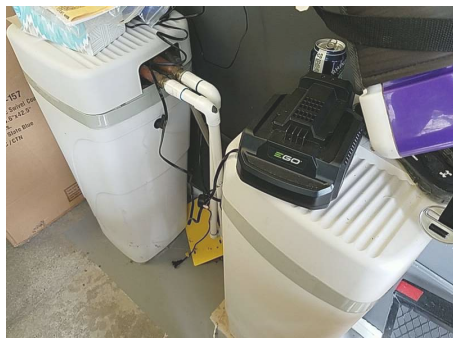
The water softener system in the garage is no longer connected to the plumbing system and is not in service. Consult with the owner to inquire if the system is intended to be removed prior to closing.

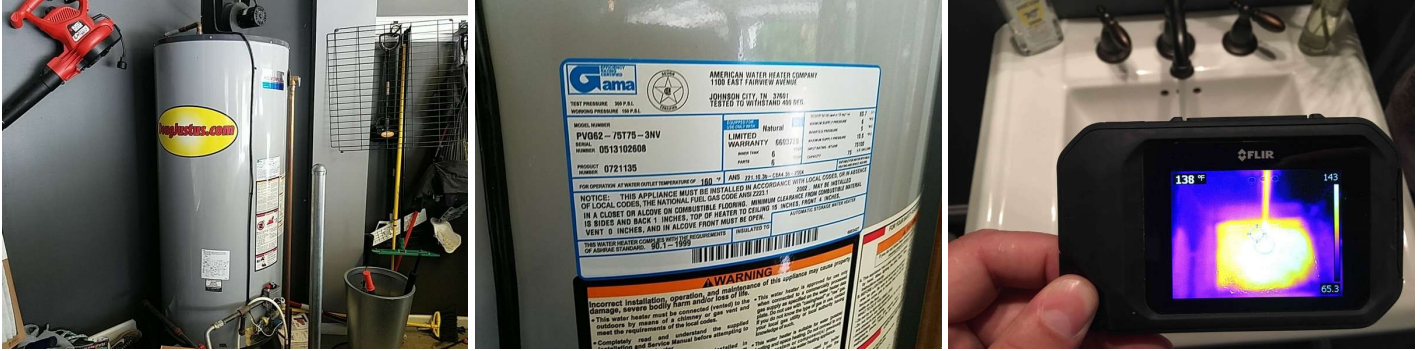
Water Heater: Nearing or Past Average Life Expectancy

The unit is nearing or has exceeded average life expectancy.

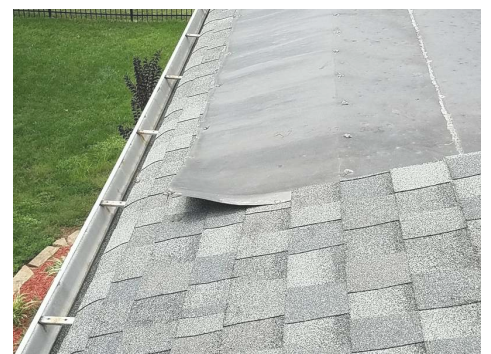
10.5.1 Roof Drainage Systems

SIGNS OF OVERFLOW

Recommendation

Contact a qualified gutter contractor

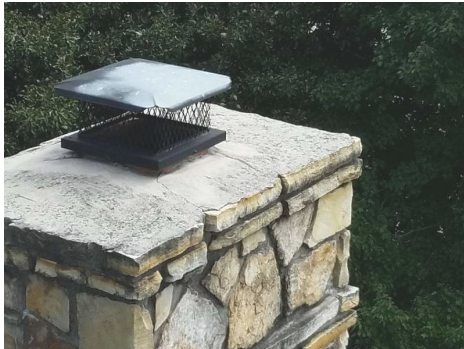
The open joints in the mortar on the chimney should be sealed to discourage water entry and further deterioration.

Contact a qualified chimney contractor.

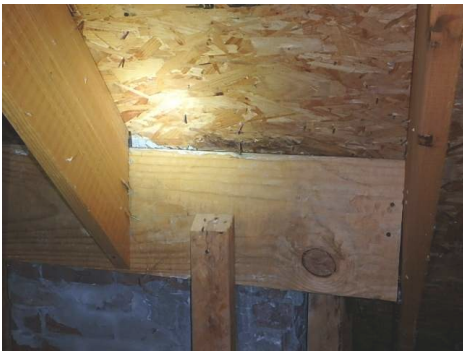
General: Signs of Previous Leak

There were signs of previous leaks in the attic. All accessible areas were tested with a moisture meter and no moisture was detected unless otherwise specified in this report.

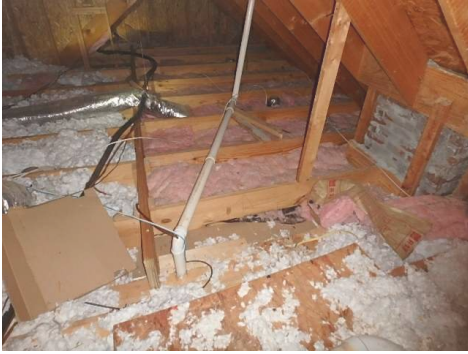
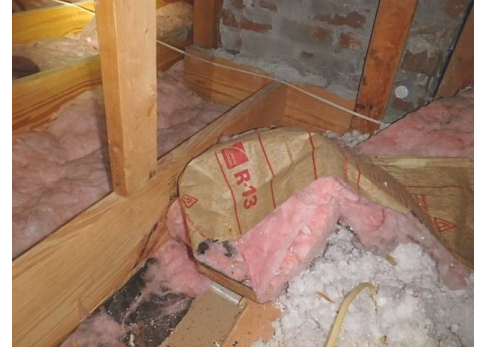
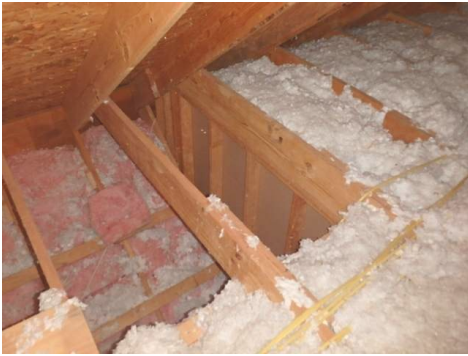
There are areas in the attic that are not properly insulated. This will reduce energy efficiency. I recommend adding or repairing the missing or weak insulation so that all areas are properly insulated for best efficiency. NOTE: current standard for attic insulation is R38.

Contact a qualified insulation contractor.

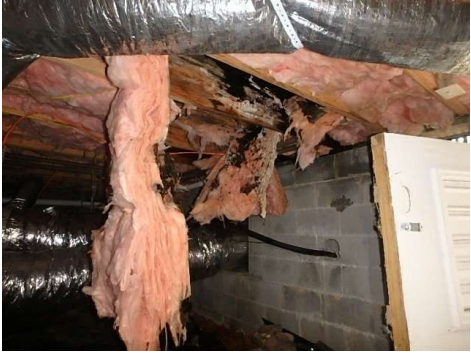
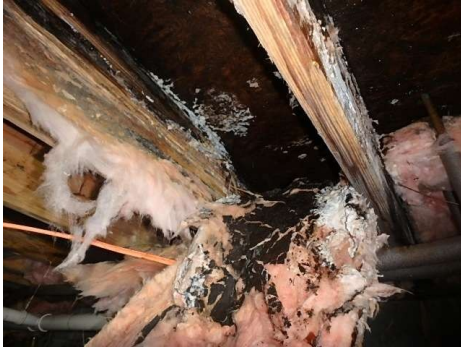
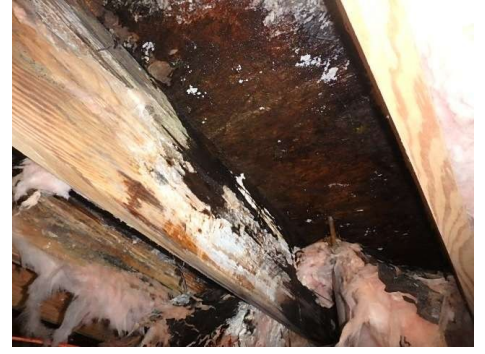
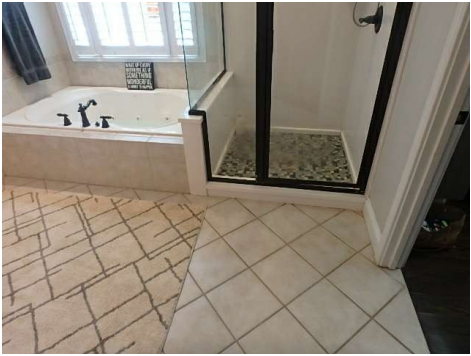
12.3.1 Framing

DAMAGED FRAMING

There was water leaking from the floor system below the master bathroom shower stall at the time of this inspection. The framing below the shower is saturated and there is deterioration to the wood. I recommend contacting a reputable contractor to make all necessary repairs to the shower and framing.

Contact a qualified general contractor.

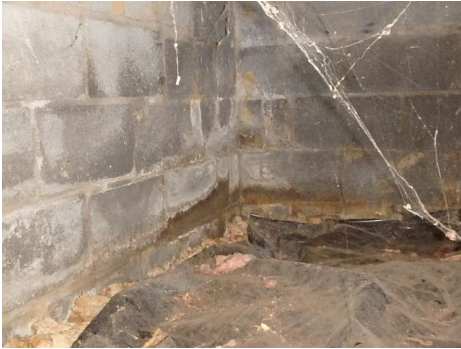
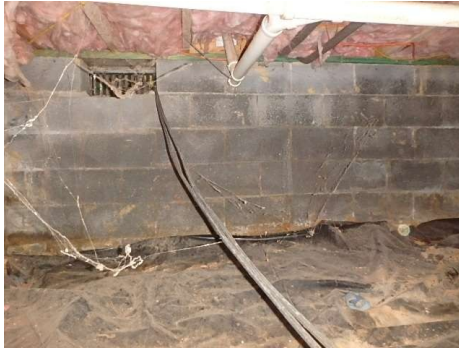
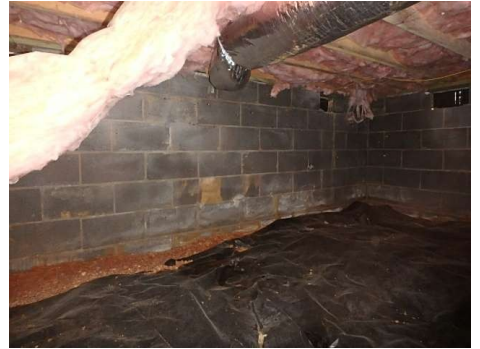
12.4.1 Foundation Walls

MOISTURE ON FOUNDATION WALLS

There were isolated areas in the crawlspace that were stained by moisture (some moisture was present during this inspection).

I recommend making necessary effort to divert water away from the foundation. Keep the gutters maintained so that water from the roof will be diverted away from the structure. Adjusting the soil in the flower beds could help to divert surface water away from the structure.

Contact a qualified professional.
